# EDGEWOOD-COLESBURG

COMMUNITY SCHOOL DISTRICT

## MASTER PLAN

Executive Summary

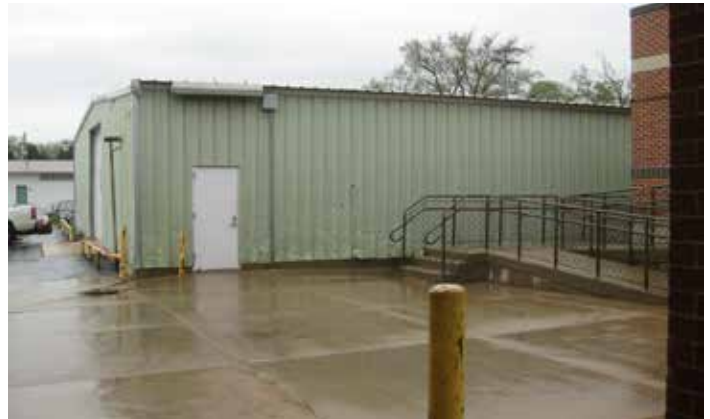
IMG\_3534.JPG

The high school shop program is housed in a separate building that sits to the north of the existing high school. It is a pre-engineered steel building with metal roof and metal siding. It also has a lean-to on the northerly side. Although the walls and roof are insulated, the building uses a lot of energy taking a toll on the school's budget. The exterior siding is beat up and showing its age. Also, since this is a separate building students must go outside to get to it. This creates a security threat since school and shop doors must be left open throughout the day for students to get between buildings.

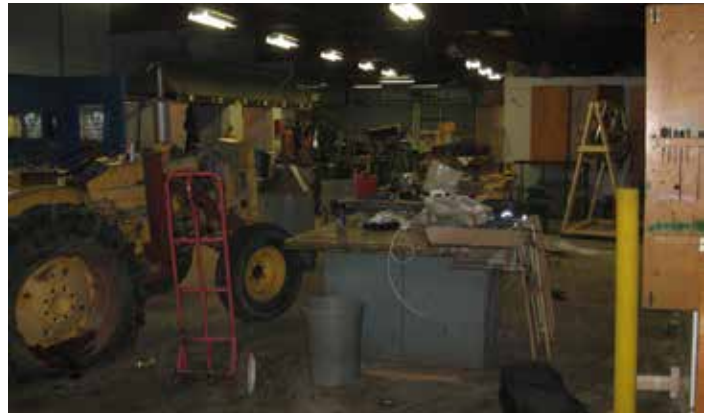
IMG\_3610.JPG

The interior of the building has concrete floors, metal liner panels and exposed insulation and exposed structure ceiling. There are some interior concrete masonry walls as well. The interior is poorly lit, crowded and dirty. A large portion of the space is being used as general school storage of desks and miscellaneous unused items. There is a double sized classroom inside the building that is in average condition.

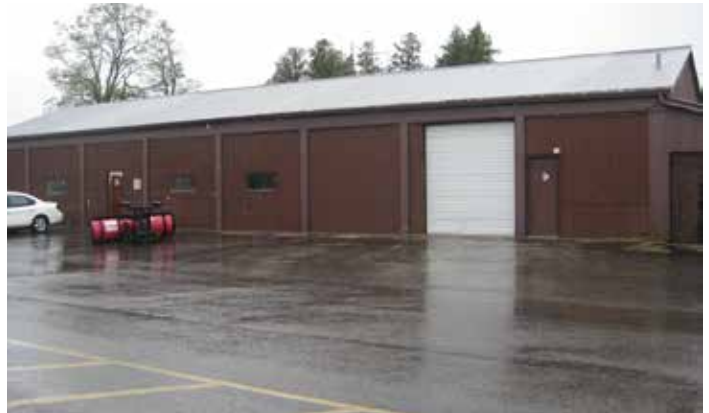
IMG\_3621.JPG

The current bus maintenance facility sits just west of the high school. It is a concrete masonry building with some siding infills. The roof is wood framed with metal panels. Walls do not appear to be insulated. The windows are not energy efficient and are past their useful life. It is recommended to consider replacing the windows with dual pane, insulated LowE glass filled with Argon to enhance energy efficiency of the windows and/or consider replacement of the entire building.

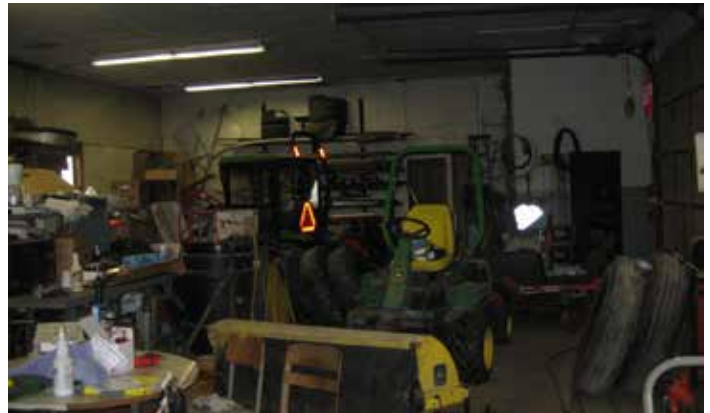
IMG\_3624.JPG

The interior of the building has concrete floors, concrete block and drywall walls and a solid ceiling with insulation placed on top of it. There are numerous areas where the ceiling is deteriorating and areas of mold can be seen due to apparent roof leaks. The concrete floor has cracks in it. The overhead doors are leaking water into the building around the bottom. The building is small, dark and overcrowded with only 1 bus stored inside.

- Lower amounts of insulation compared to a newer building increases energy usage.
- Windows are not energy efficient and are past their useful life.
- The building is old and deteriorating. Thought should be given to replacing it in the near future.
- Overcrowding due to storage of unnecessary items could be a safety concern.

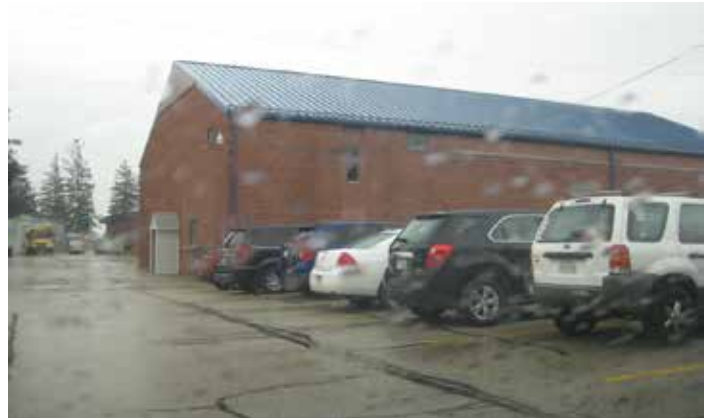
IMG\_3497.JPG

The original section of the building is a two-story structure constructed of masonry bearing walls with brick cladding. This portion of the building was found to be in average condition for its age with minor masonry repairs needed at various locations due to damage and deterioration. The addition to the east is single story. It is constructed out of masonry cavity walls with brick exterior, wood truss roof framing and concrete slab on grade floors. The brick is in overall good condition on the newer single story addition.

The roof on the majority of the building is a steep slope standing seam metal roof. The insulation amounts could not be verified, however, it is assumed due to the age of the building and recent Energy Code requirement increases that it is below current Energy Code minimums. A newer building with code minimum insulation amounts in both the walls and roof would have a positive impact on the energy required to condition the building.

The exterior windows and doors are aluminum frame windows with dual pane insulated glass. Some windows are also wood clad windows with insulated glass. The windows are not energy efficient and are past their useful life. It is recommended to consider replacing the windows with dual pane, insulated LowE glass filled with Argon to enhance energy efficiency of the windows. The exterior doors are a combination of aluminum full glass entrance doors and also hollow metal doors and frames. All doors, frames and glass appear to be in good working condition. All doors appear to have the proper egress panic devices where required.
