# EDGEWOOD-COLESBURG

COMMUNITY SCHOOL DISTRICT

## MASTER PLAN

Executive Summary

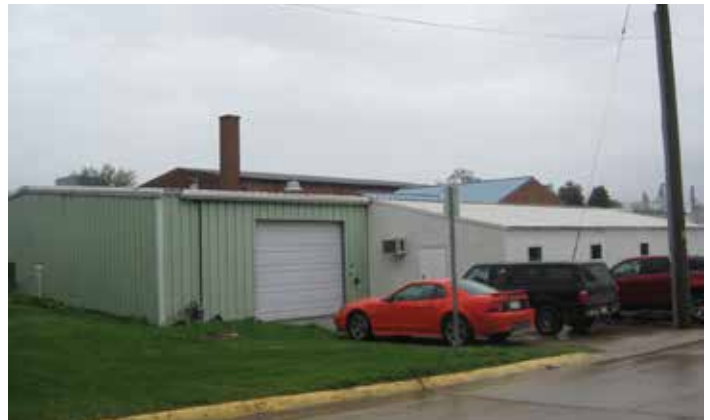
IMG\_3639.JPG

The interior of the building has concrete floors, metal liner panels and exposed insulation and exposed structure ceiling. There are some interior concrete masonry walls as well. The interior is poorly lit, crowded and dirty. A large portion of the space is being used as general school storage of desks and miscellaneous unused items. There is a double sized classroom inside the building that is in average condition.

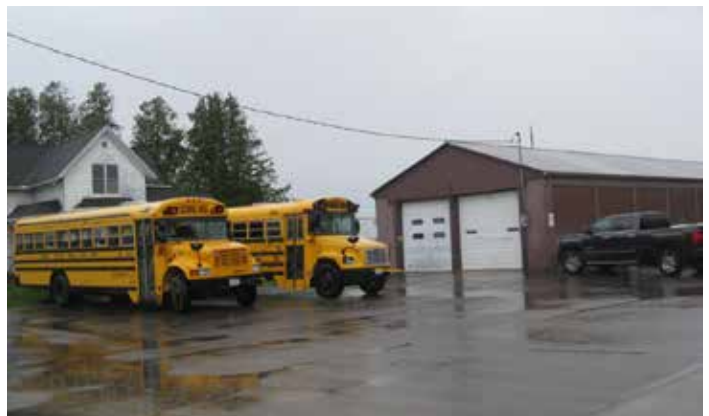
IMG\_3633.JPG

The current bus maintenance facility sits just west of the high school. It is a concrete masonry building with some siding infills. The roof is wood framed with metal panels. Walls do not appear to be insulated. The windows are not energy efficient and are past their useful life. It is recommended to consider replacing the windows with dual pane, insulated LowE glass filled with Argon to enhance energy efficiency of the windows and/or consider replacement of the entire building.

- Windows are not energy efficient and should be replaced.
